PUGET SOUND EARTHQUAKE ALERT

DUVALL EARTHQUAKE OF MAY 2, 1996

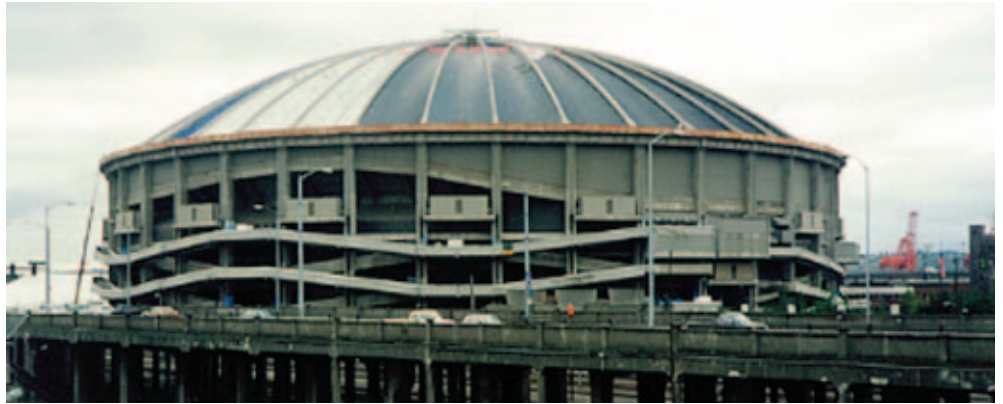
The May 2 event caused no damage to the Kingdome.

Very little movement was noticed along the expansion joints that separate the Kingdome into six segments, indicating that the Kingdome apparently moved as a unit. The performance of the nonstructural elements within the Kingdome was good. There was no indication of damage to ceiling tiles, television monitors, or other nonstructural items. Light fixtures were all in place, and items on shelves did not fall off during the event. After the inspection was complete, a press conference was held to announce that the Kingdome was safe and available to resume baseball play that evening.

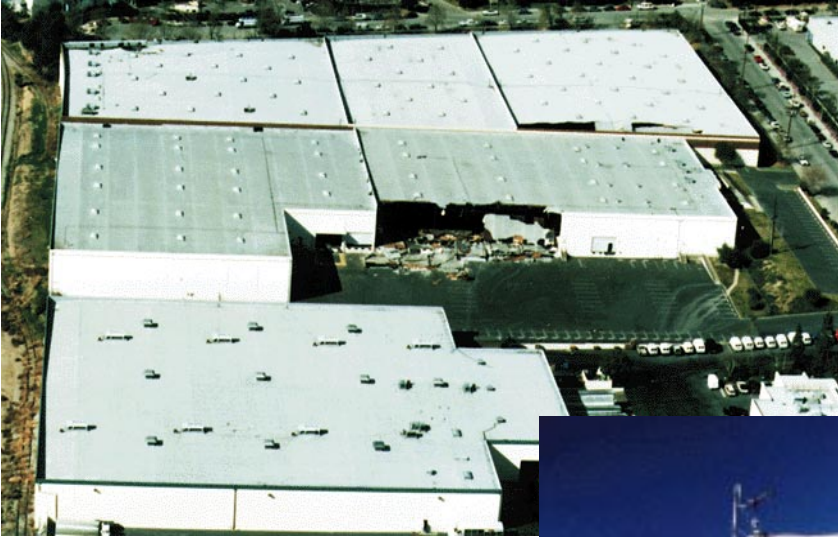
Typical tilt-up wall and roof failure due to out-of-plane loads.

Structures with wood roofs and perimeter **reinforced masonry or precast concrete tilt-up** walls are the most common low-rise, light industrial and commercial construction in the western United States. The 1994 Northridge Earthquake in California caused partial collapse of more than 400 such structures, many of which were of recent vintage. The primary vulnerability of these buildings is inadequate connections between their heavy perimeter walls and flexible floor and roof framing systems.

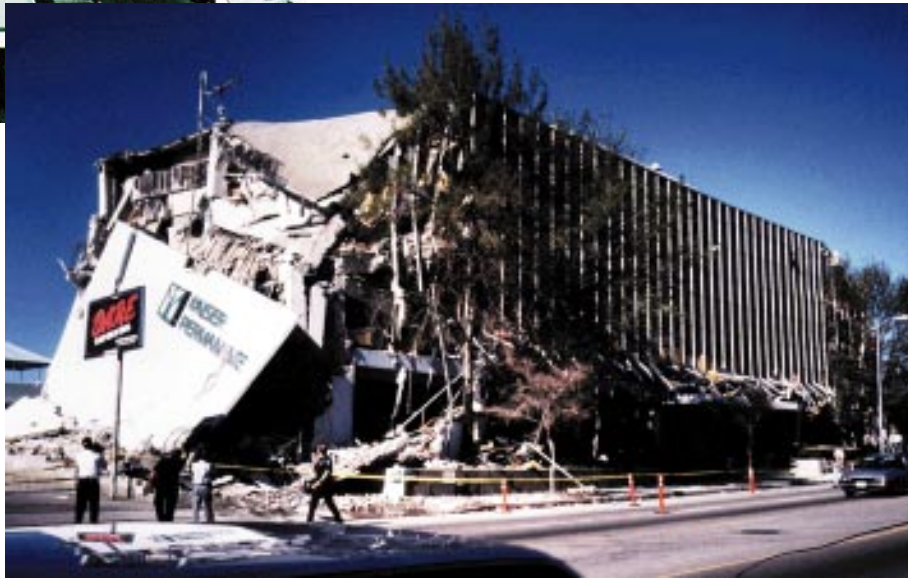
Older (pre-1970s), **reinforced concrete moment-frame** and flat-slab buildings are very common in Seattle, Portland, and Vancouver, B.C., and have experienced catastrophic collapses in past

Collapse of this medical building is typical of older concrete building performance.

earthquakes. This experience was repeated in the Northridge Earthquake. Among modern engineered structures, concrete parking garages had the greatest damage; eight totally or partially collapsed. Three of the collapsed structures had been built within the last six years.

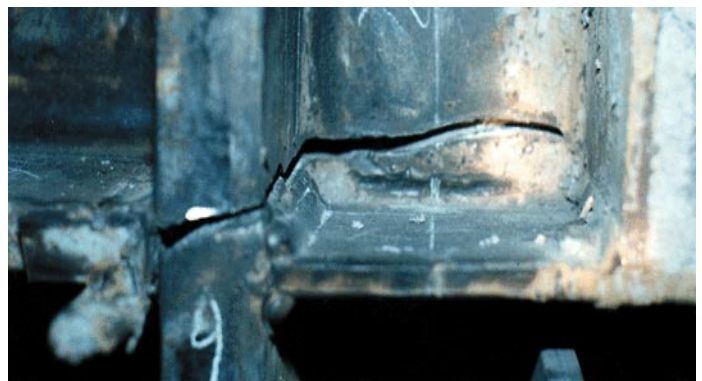
Historically, **steel-frame buildings** have been considered as one of the most earthquake-resistant construction types. However, more than 100 modern steel-frame buildings were severely damaged by the Northridge Earthquake. Repair costs for some structures have exceeded 30% of the replacement costs, and a few have been written off as total losses. In a number of moment-resisting steel frames, highly stressed welded beam-column connections served as initiating zones for brittle fractures that propagated through the connections. Research undertaken since the earthquake indicates that other contributing causes could include the basic strength and toughness properties of the structural steel and welding materials.

Typical connection fracture in a moment-frame building.
